# Challenges in Polar casualty response

- The tale of the “Northguider”

# 28<sup>th</sup> December, 2018

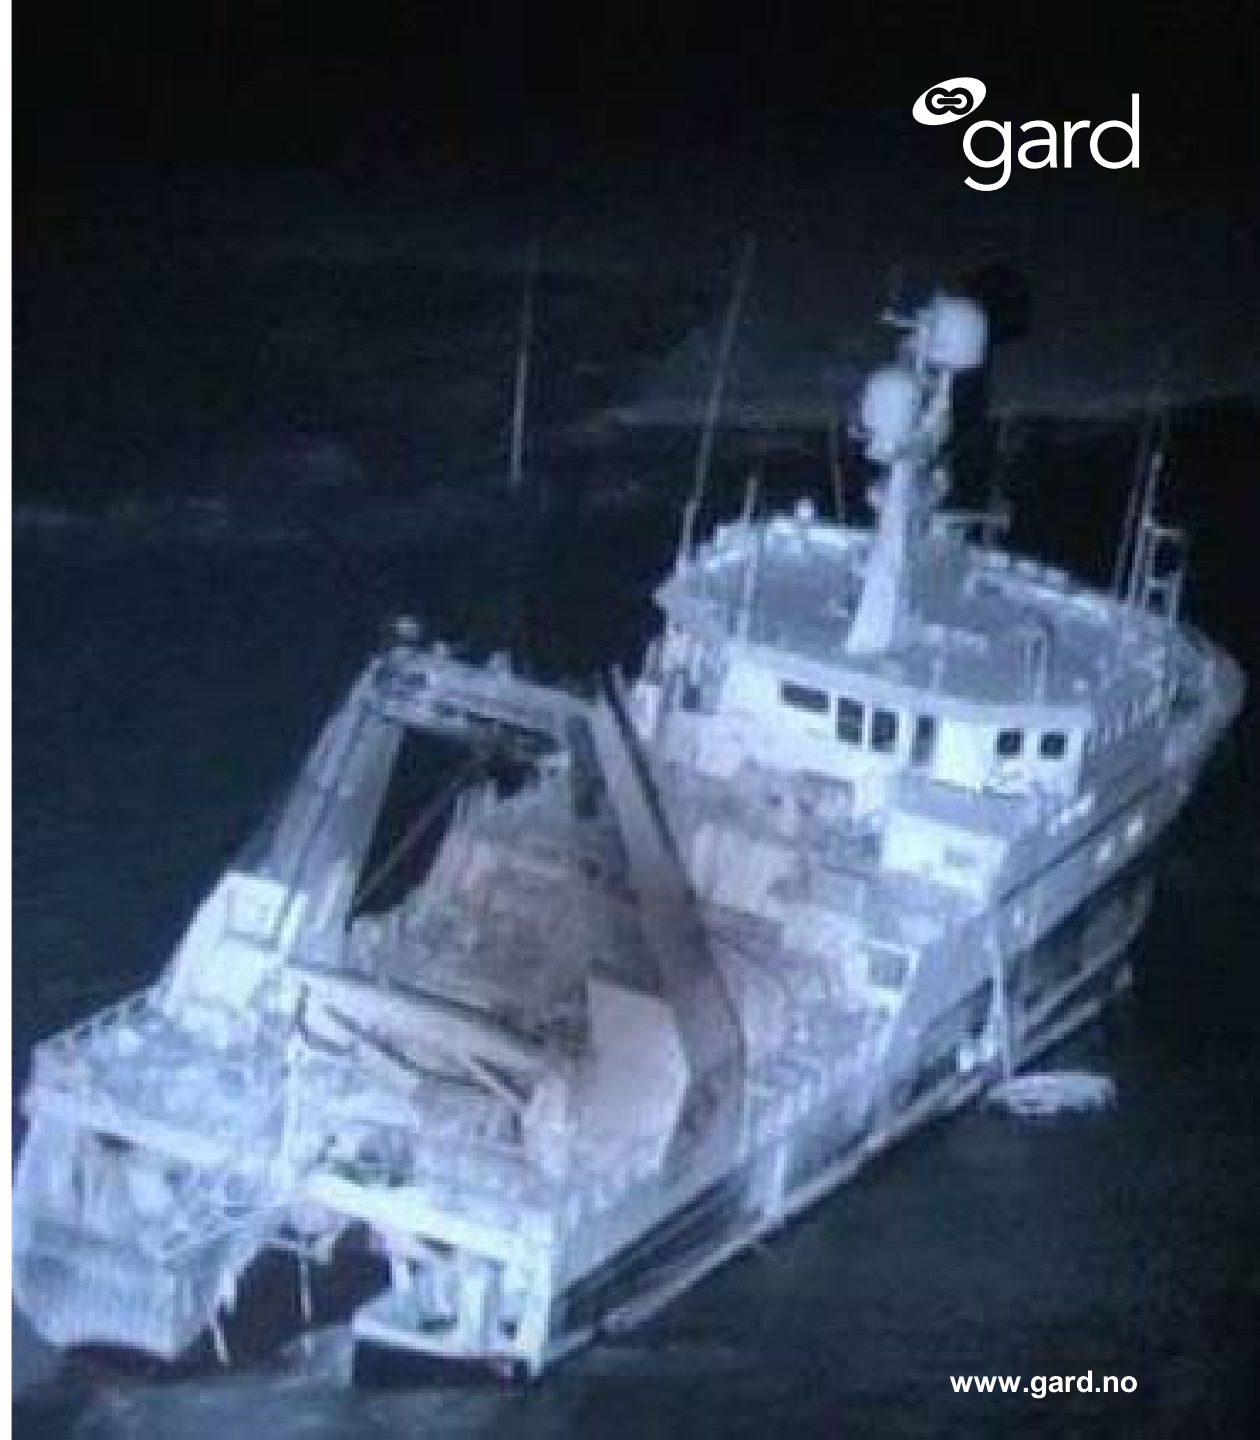
- Ran aground while trawling in Hinlopen Strait
  - 79 53,9 N – 018 04,7 E
- Approximately 332 m<sup>3</sup> of fuel (diesel oil)
- Engine room flooded and vessel blacked-out
- List angle: 17 degrees
- No daylight
- Air temp. approximately - 30 degrees Celsius

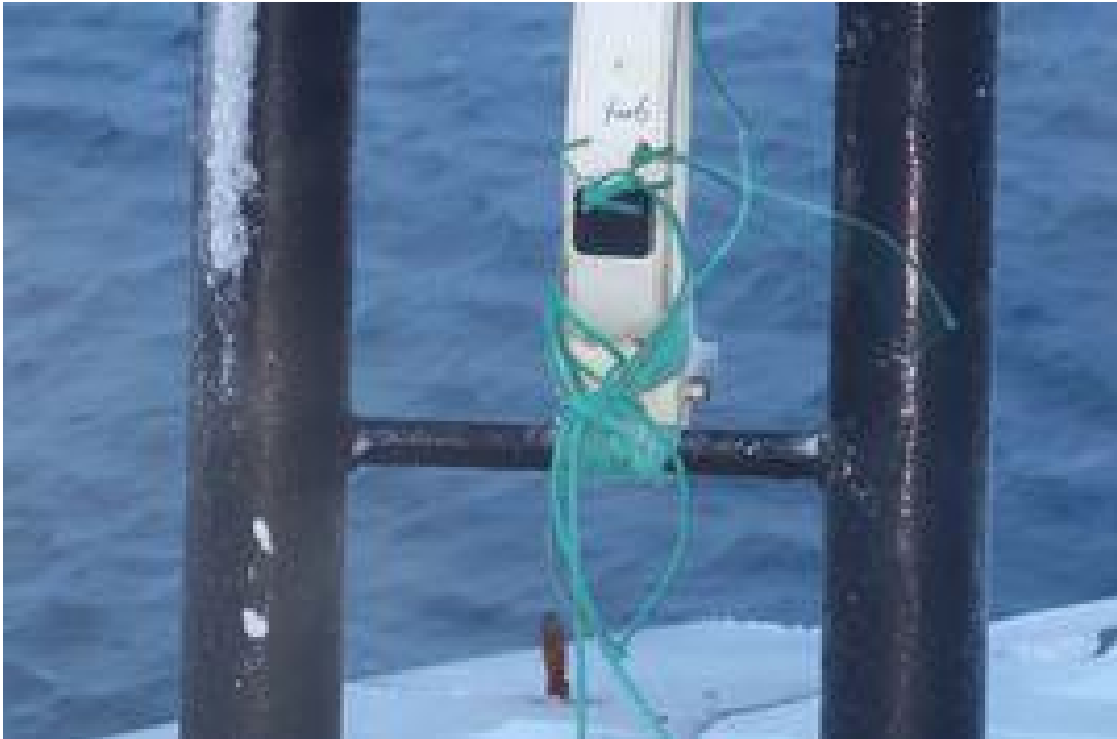
**Movement sensors installed**

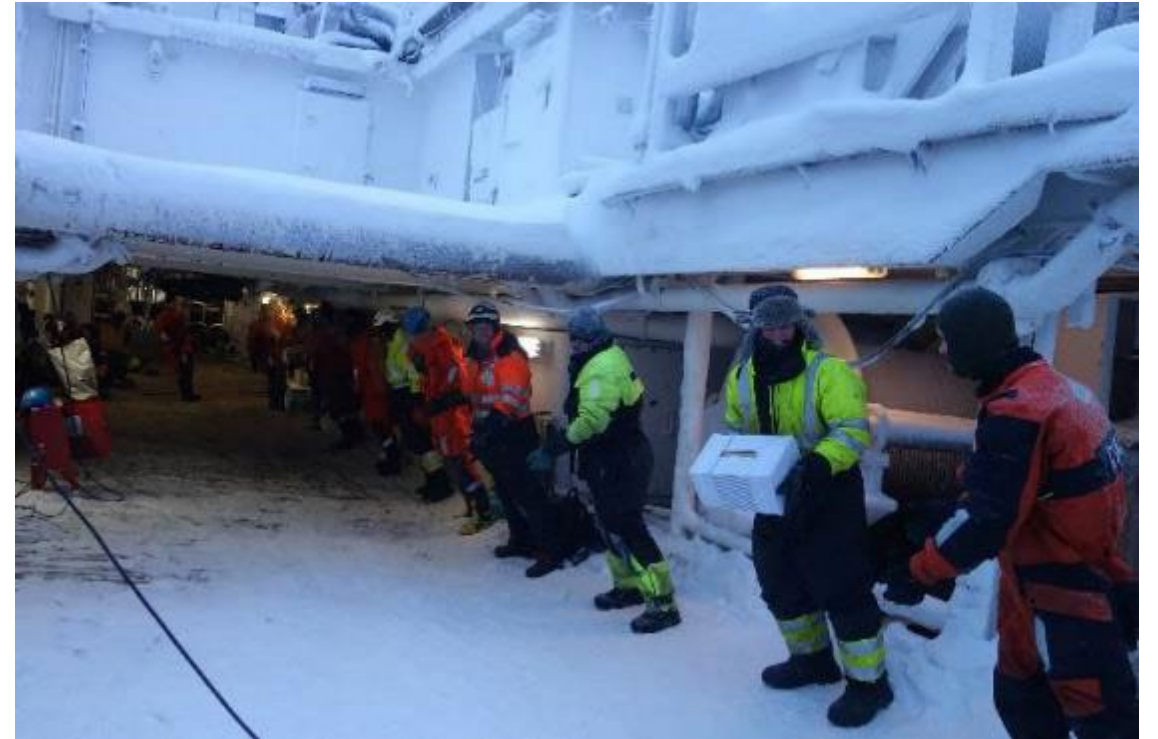
**Removal of goods and hazardous waste**
